# The I-ENG-A Report

## INSULATED GLASS (IG) SEAL FAILURE: SUDDEN AND ACCIDENTAL OR INEVITABLE?

Article by: James A. Skaret, PE; North Central Consultants, Ltd., I-ENG-A North Dakota

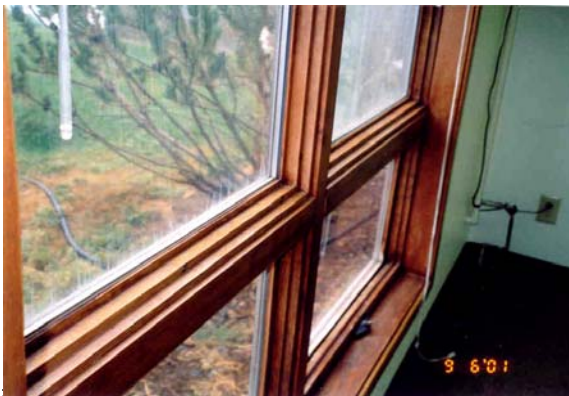
Example of IG Window Unit Failure: Note “streaking” on glass and “foggy” air space.

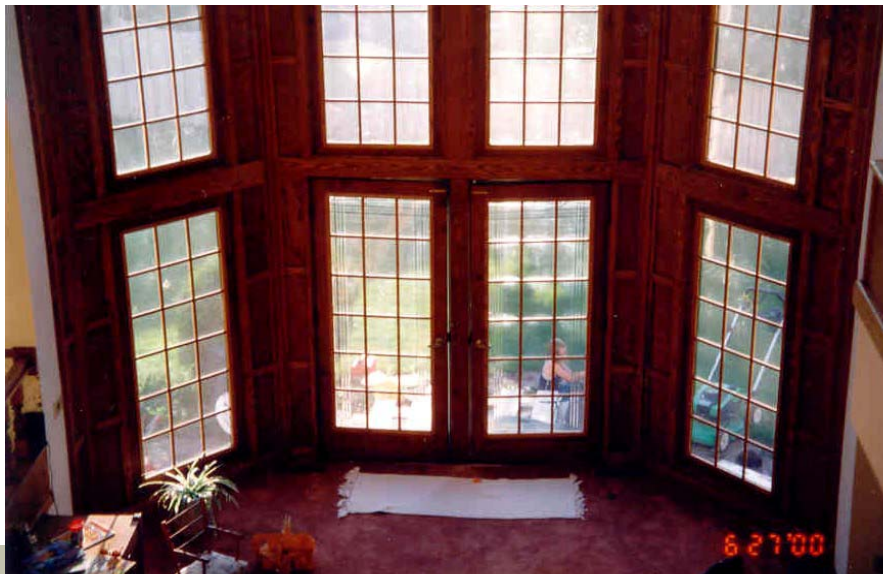
*Example of Multiple IG Window Unit Failure: Note "streaking" on glass and "foggy" air space.*
